Photo Log: 9-13-2011

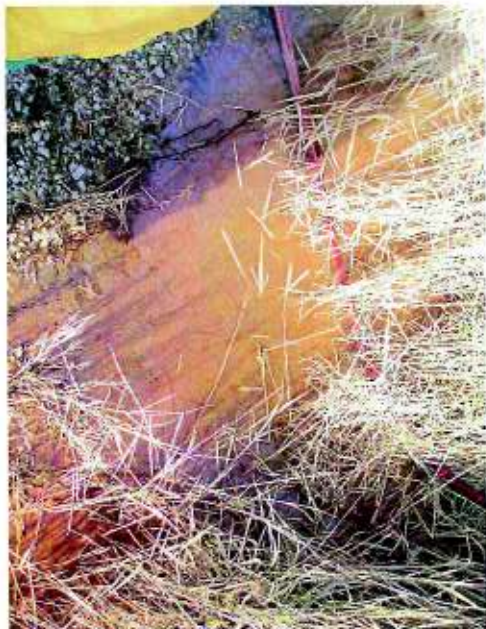
P9130003

Sample area for BIP1 and 1A. Facing north. Water pooling from discharge pumped from secondary containment of T501 to the grassy area north of T501. The water had mild turbidity and was light brown/orange in color. A sheen was present.

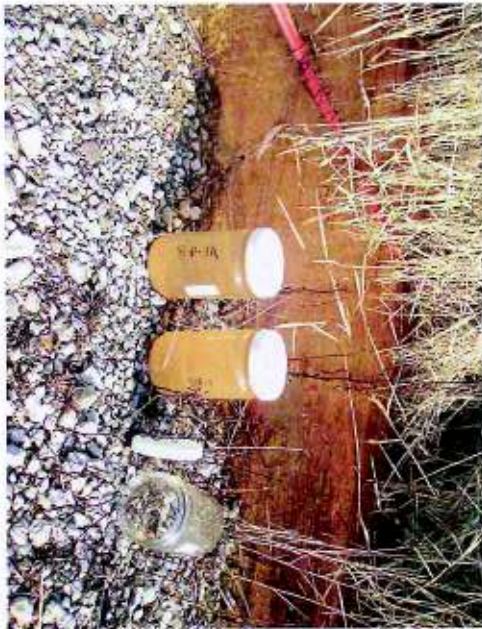
P9130004

See caption for P9130003. Facing north. This photo also shows sample jars and the jar used to scoop the sample.

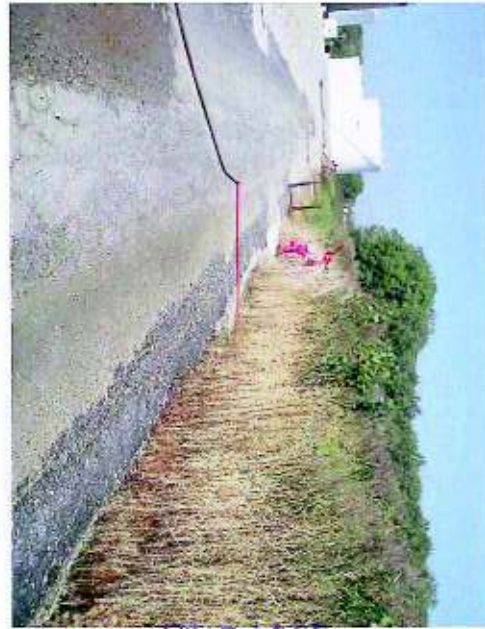
P9130005

Facing west. The discharge identified in P9130003 was pumped, in part, through a flexible hose that went approximately 15 feet into the grassy area north of the site.

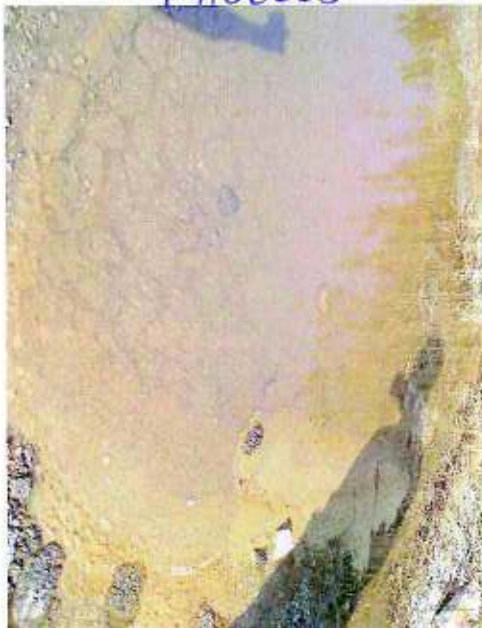
P9130006

Sample area for BIP2 and 2A. Facing northwest. The discharge identified in P9130003 pooled toward the eastern border of the site. This photo shows the eastern edge of the pool. The water was moderately turbid, light brown, and had a whitish brown scum and oil sheen on the surface.

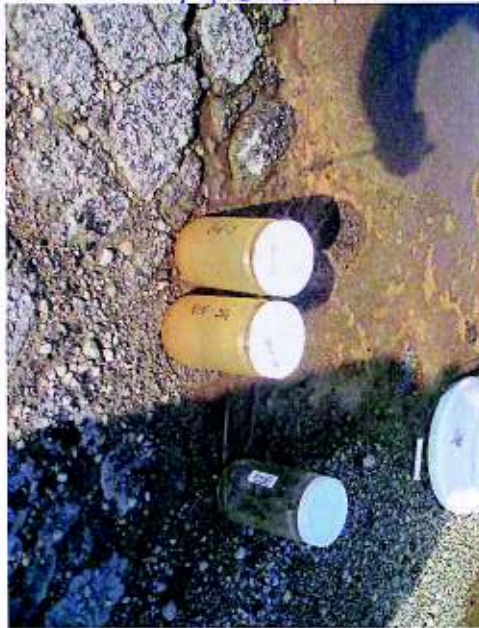
P9130007

See the caption for P9130006. This photo also shows the sample jars and the jar used to scoop the samples.

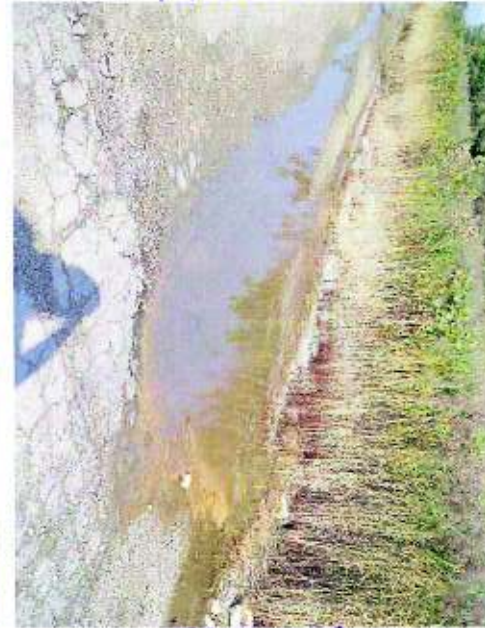
P9130008

A broader view of the area identified in P9130006.

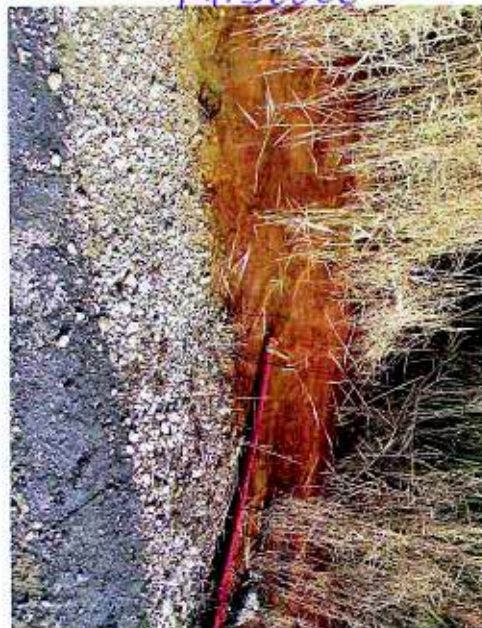
P9130009

Sample area for BIP3 and 3A. Facing north. Though the sample area is the same as that for BIP 1 and 1A, the sample is not from the pool of water, but rather from flowing water directly out of the hose. The samples were clear with specs of organic matter.

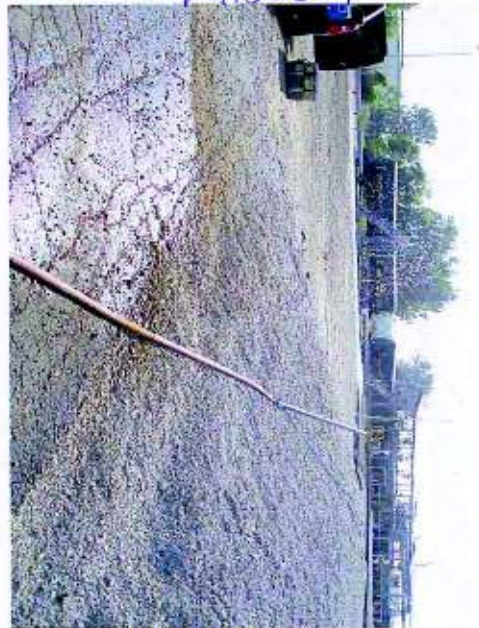
P9130010

Facing southeast. The flexible hose carrying the discharge from the secondary containment of T501 had a small leak.

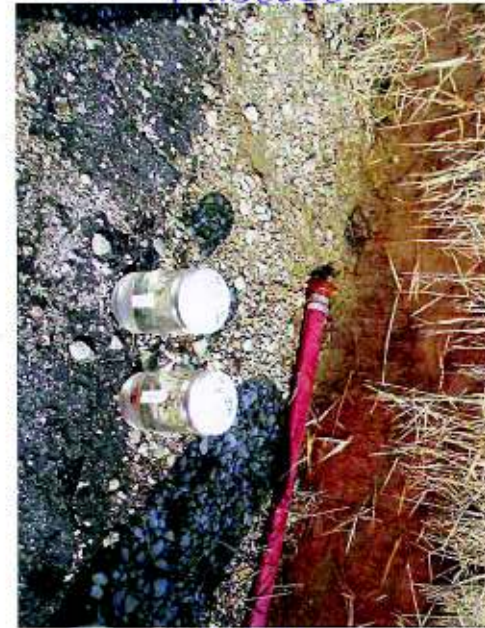
P9130011

See the caption for P9130009

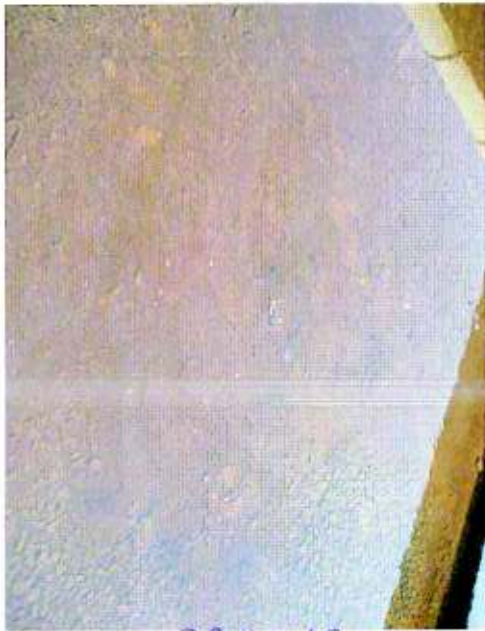
P9130012

Sample area for BIP4 and 4A. Facing northeast. Liquid accumulated in the northeast corner of the secondary containment for T503. In the center of the photo, black holes the size of quarters appear beneath the water. Bubbles were emanating from those holes. The water in the pool was dark brown and clear with an oily sheen.

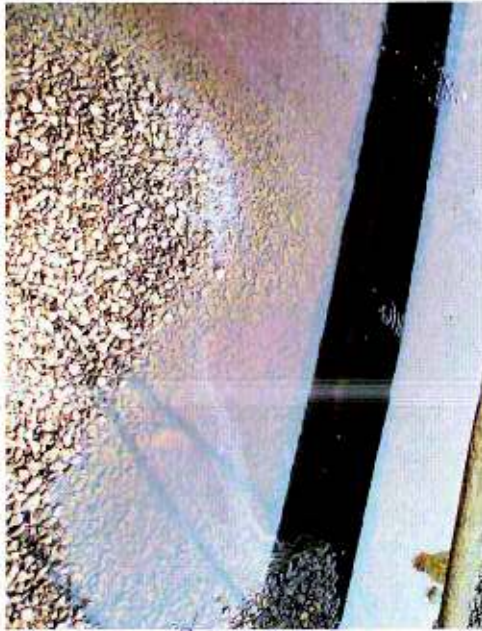
P9130013

See caption for P130012. The water in the sample jars was a light brown/yellow color.

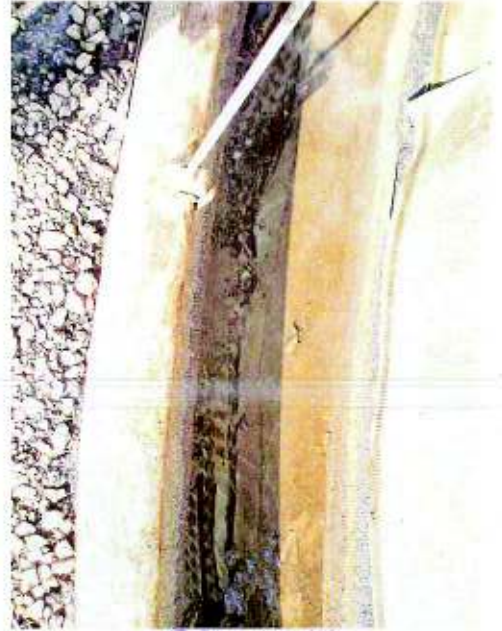
P9130014

The containment trough around T503 was nearly empty as the material that had been in it the day prior, September 12, 2011, had drained overnight. A dead frog was in this trough. The frog is in the center of the photo, just above the line of shadow.

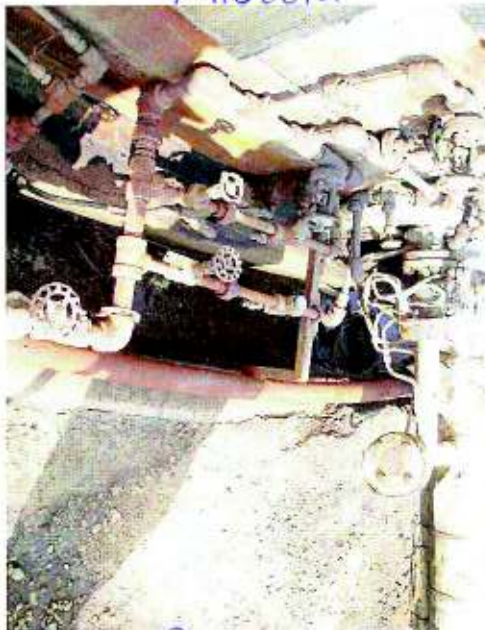
P9130015

See caption for P9130014. The drain is shown in this photo.

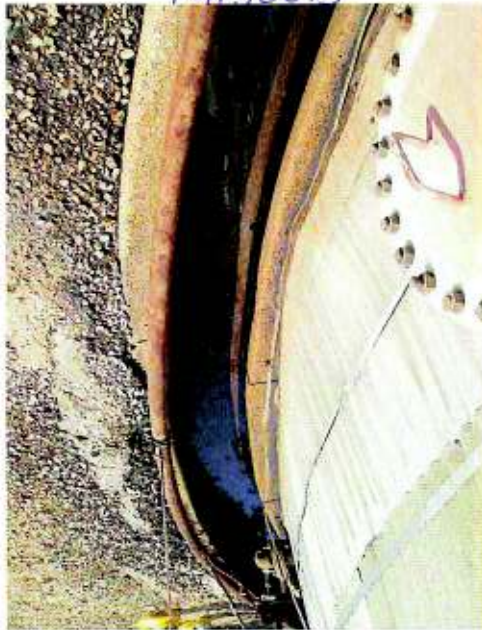
P9130016

This photo is oriented on its right side. See caption for P130014.

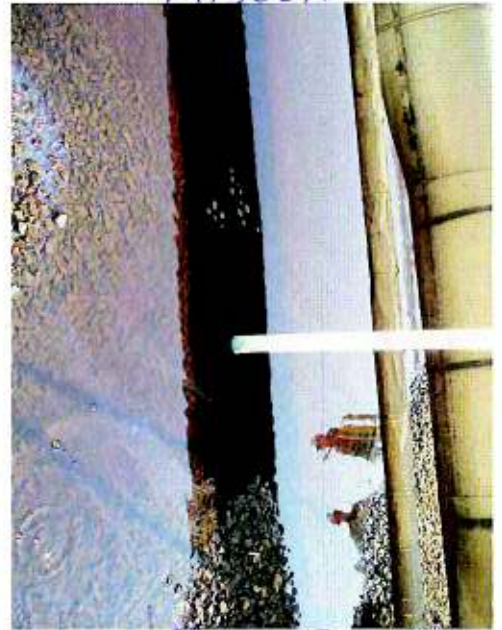
P9130017

See caption for P9130012. This photo includes an image of the coliwasa initially used to try to collect the sample. The coliwasa was not effective. The samplers switched to a scoop instead.

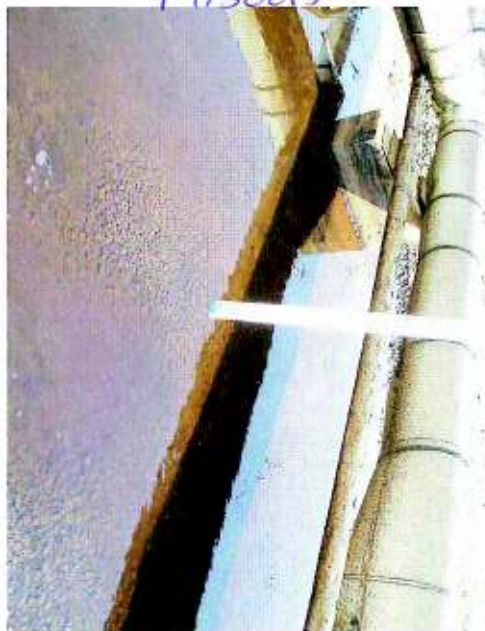
P9130018

See caption for P9130017.

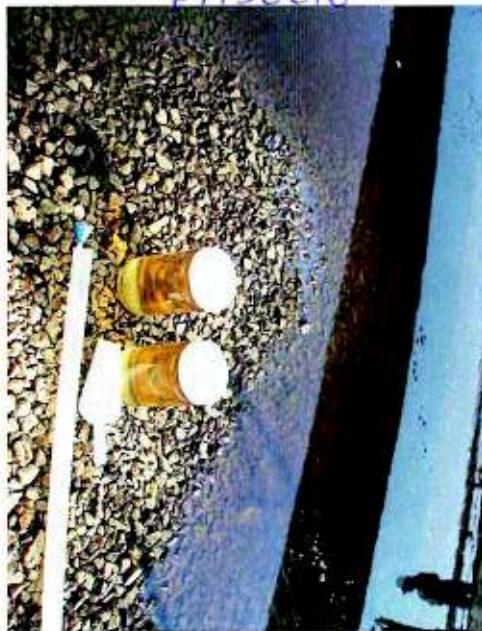
P9130019

See caption for P9130012.

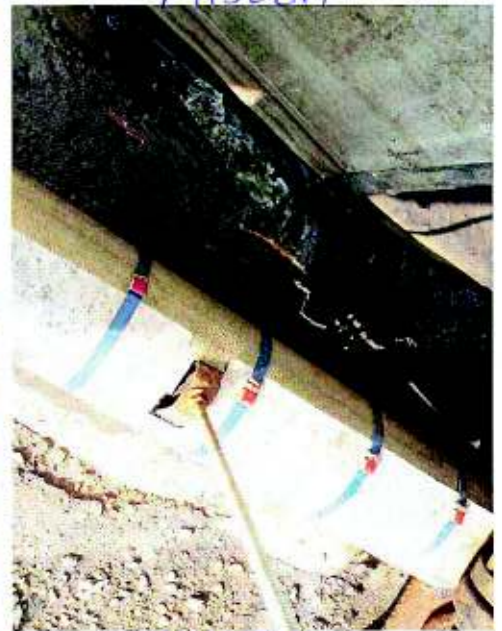
P9130020

The trough of T502 was lower than the previous day, September 12, 2011; however, some liquid was still present. A dead bird was in this trough. The legs and tail of the bird can be seen in the trough between the second and third blue and red bands around the pipe running parallel to the trough.

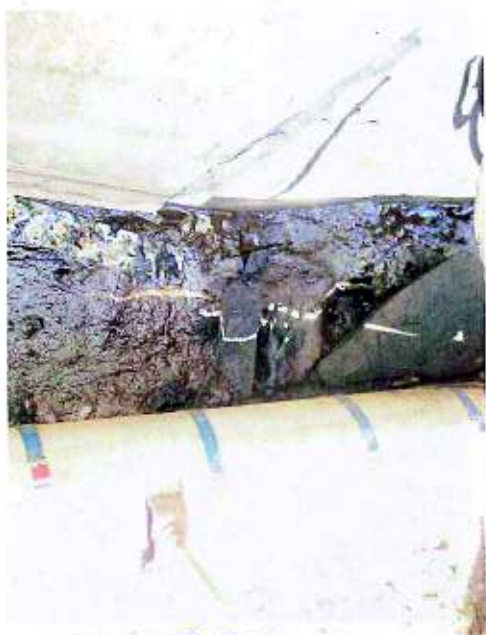
P9130021

See caption for P9130020.

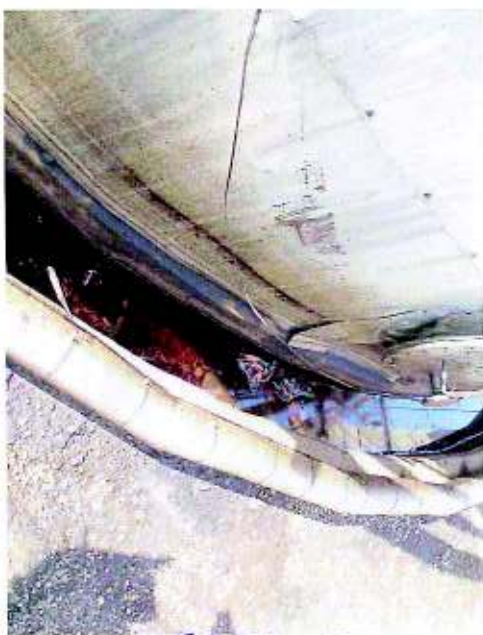
P9130022

See caption for P9130020

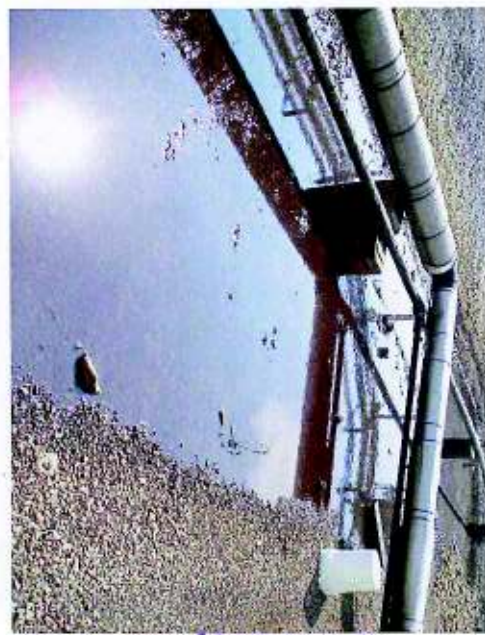
P9130023

Sample area for BIP5 and 5A. Facing south. Liquid accumulated in the southeast corner of the secondary containment for T502. The water was dark brown and clear with an oily sheen.

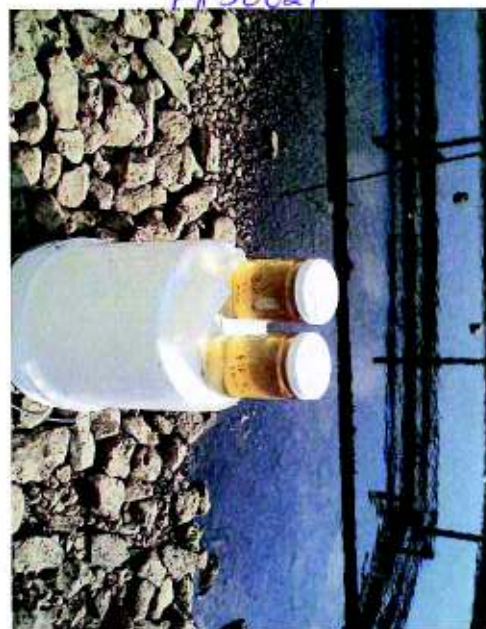
P9130024

See caption for P9130023. The water in the sample jars was a light brown/yellow.

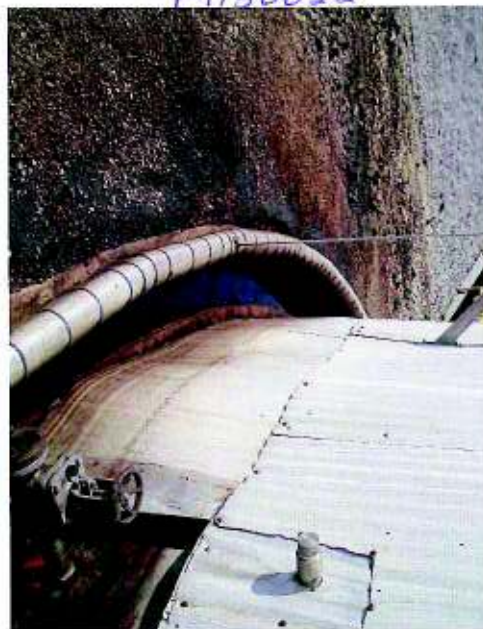
P9130025

See caption for P9130020.

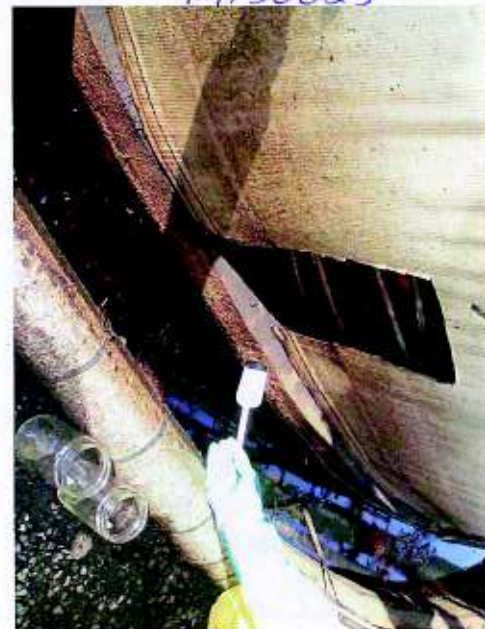
P9130026

Sample area for BIP6 and 6A. The depth of sediment and liquid in the trough around T502 was approximately one inch as evidenced by the dark portion shown on the scoop in this photo.

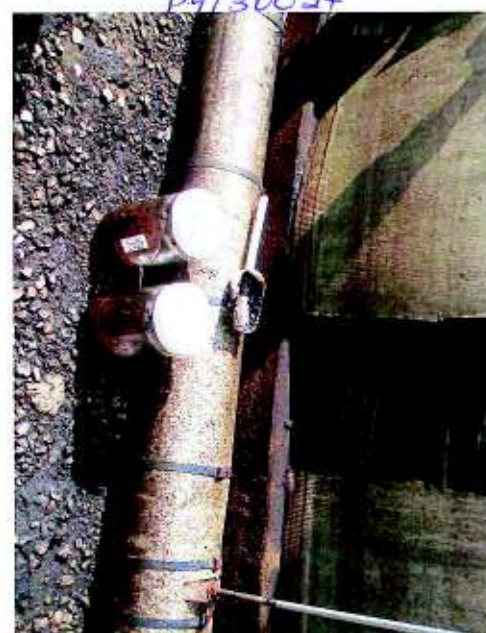
P9130027

See caption for P9130026. The amount of supernatant liquid in the trough was minimal and resulted in partial filling of the sample jars.

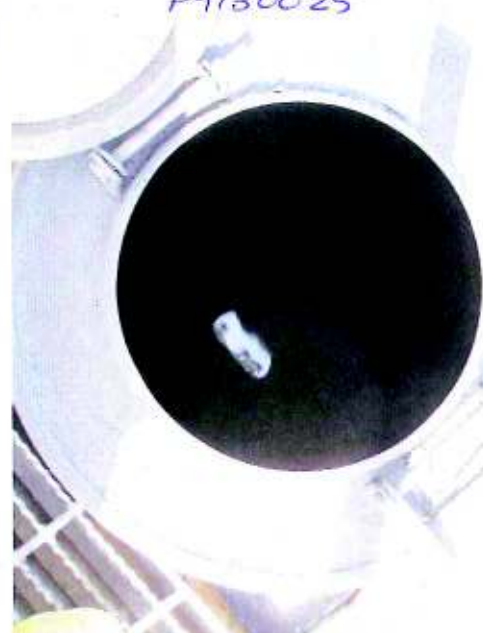
P9130028

Sample area for BIP7 and 7A. View of the waste within the chuck wagon through the open hatch on top of the chuck wagon. The chuck wagon is a large container that holds waste pulled off of the API separator.

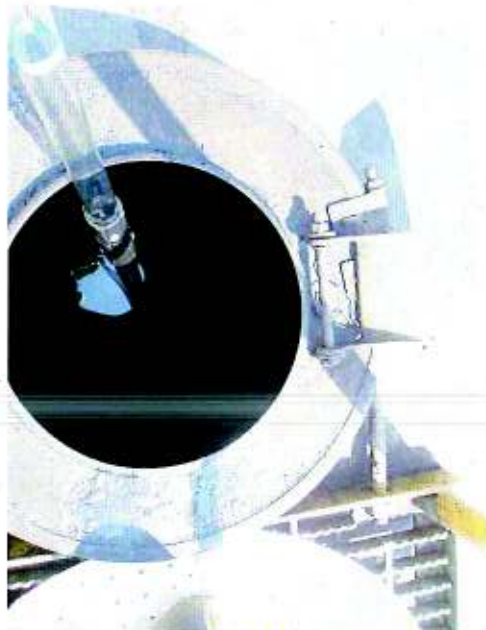
P9130031

See caption from P9130028. Photo of the sampling tool referred to as a "Sludge Judge" being used to collect a portion of a sample is being pulled from the chuck wagon.

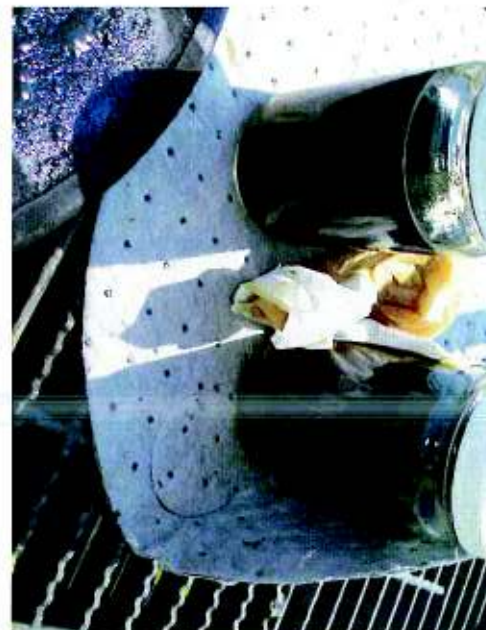
P9130032

See caption from P9130028. Sample jars of very dark brown liquid from the chuck wagon photographed immediately after filling.

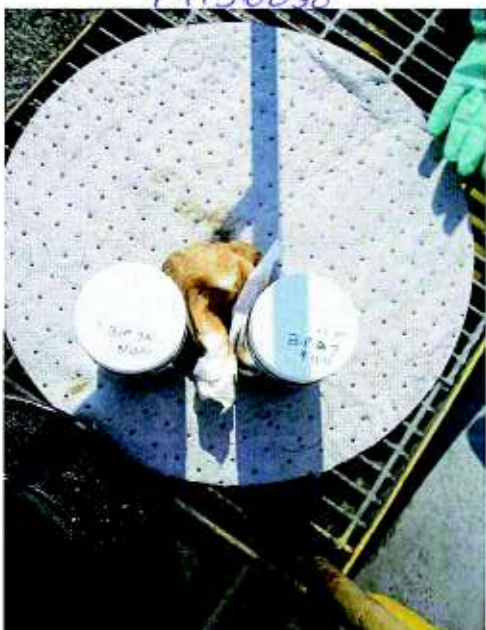
P9130033

See caption from P9130032.

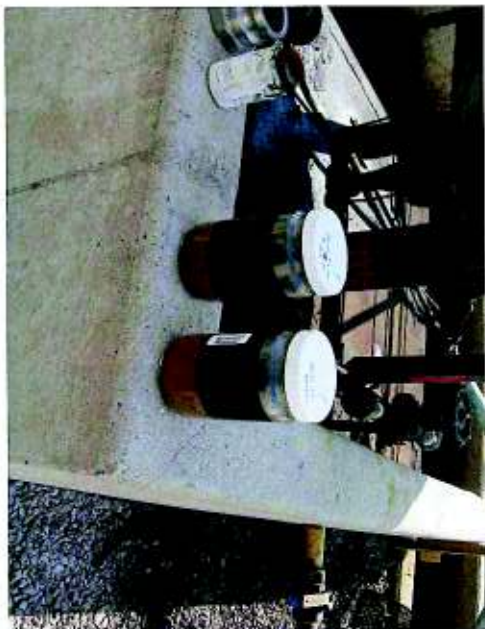
DSCN1343

Photo of sample jars identified in P9130032 after a few minutes had passed. The samples in the jars, which are now positioned on the secondary containment berm of a tank associated with the API separator, show a dual phase liquid.

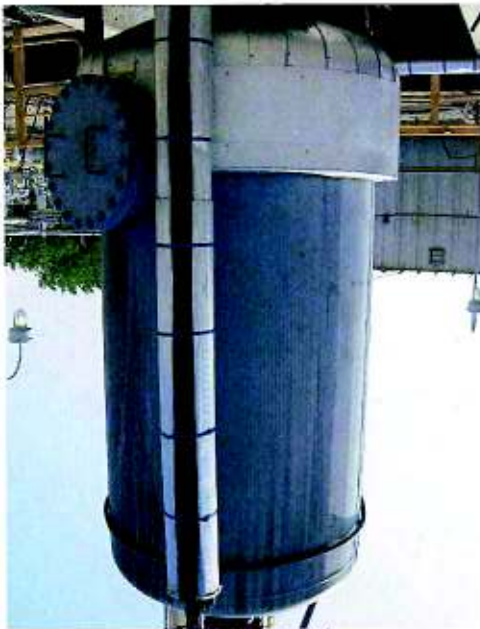
DSCN1344

This photo is oriented on its right side. Facing east. The tank in this photo is associated with the API separator and stores the oily fraction that is pulled off of the API.

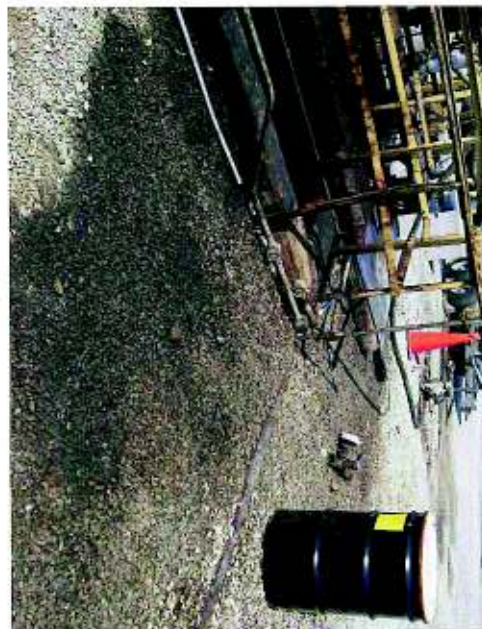
DSCN1345

Facing northwest. Darkly stained soil to the east of the API separator. The 55-gallon drum is a satellite container for oil-absorbent pads that are used to collect oil that passed through the weirs on the API before the water is discharged to the sewer. The drum was labeled with a "Hazardous Waste" label and was closed.

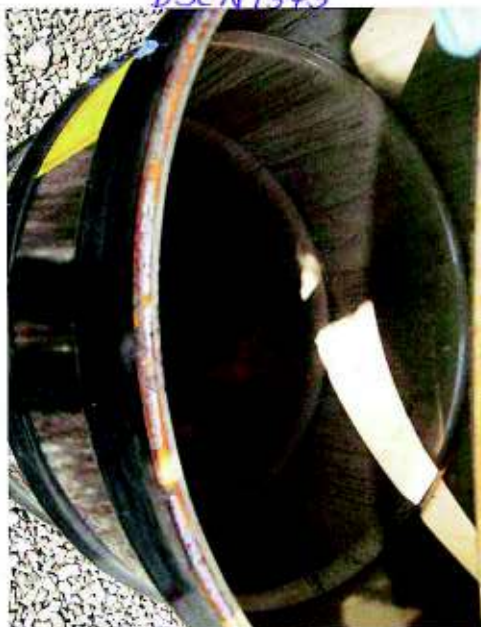
DSCN1346

A view of the waste pads inside the 55-gallon drum identified in DSCN1345.

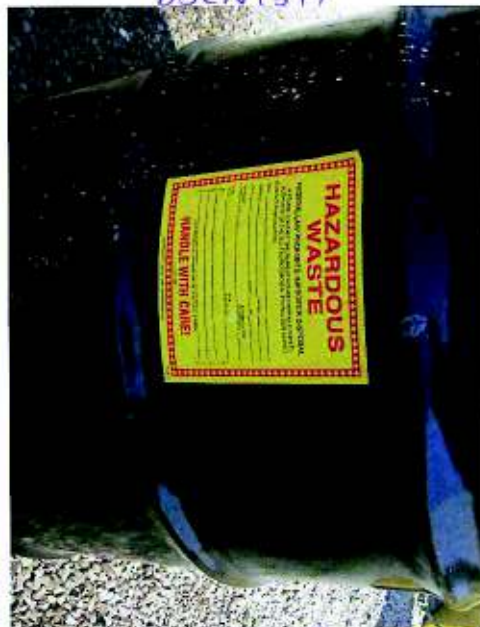
DSCN1347

A view of the label and markings on the 55-gallon container identified in DSCN1345. The pads are managed as benzene contaminated hazardous waste.

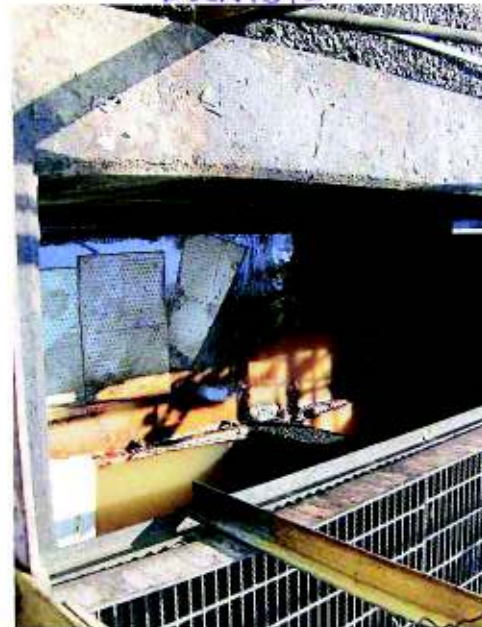
DSCN1348

The oil-absorbent pads are used as part of the final catch for oily waste in the API separator. These pads will be retrieved and placed in the 55-gallon drum identified in DSCN1345.

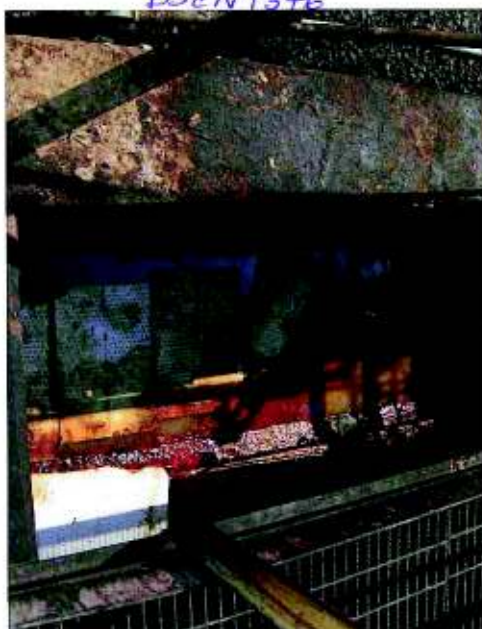
DSCN1349

See the caption for DSCN1348.

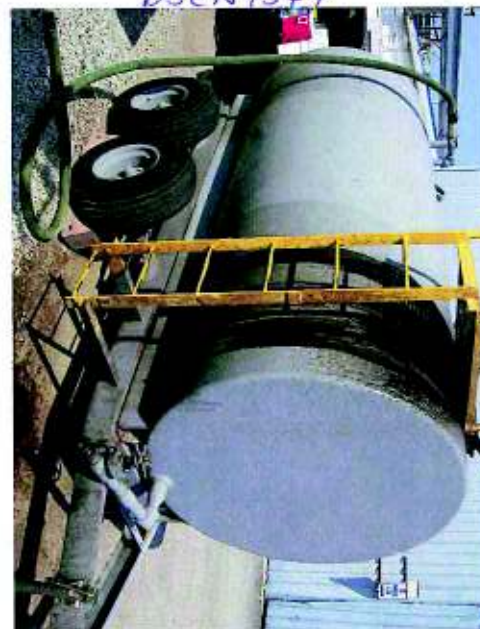
DSCN1350

View of the chuck wagon identified in P9130028 from which samples BIP7 and 7A were taken. The hatch opening to the container is located above the stained portion of the container. The soil below an open-ended pipe leading attached to the bottom front of the container was also stained.
